**FINAL REPORT ON MPCD APPLICATION
TRIAL PROJECT**

B-DERE PILOT PROJECT SITE

**SWISSCON OIL&GAS
SERVICES**

PROJECT TITLE	PRODUCT PILOT TEST REMEDIATION OF CONTAMINATED LAND
CONTRACTOR	SWISSCON OIL SERVICES LTD
PRODUCT NAME	MOLECULAR POTENTIALLY CHAIN DISINTEGRATOR (MPCD)
CLIENT	SPDC
PROJECT START DATE	OCTOBER ,2013
PROJECT END DATE	MARCH, 2014

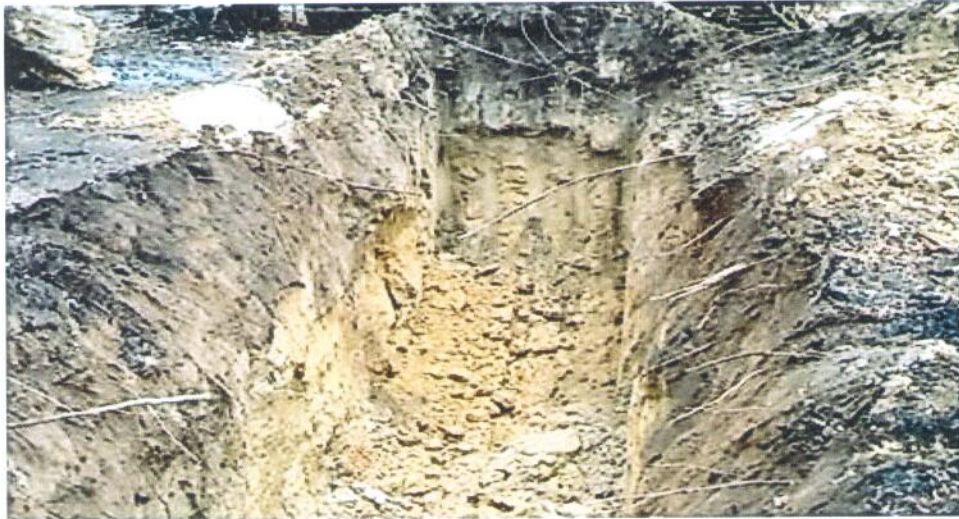
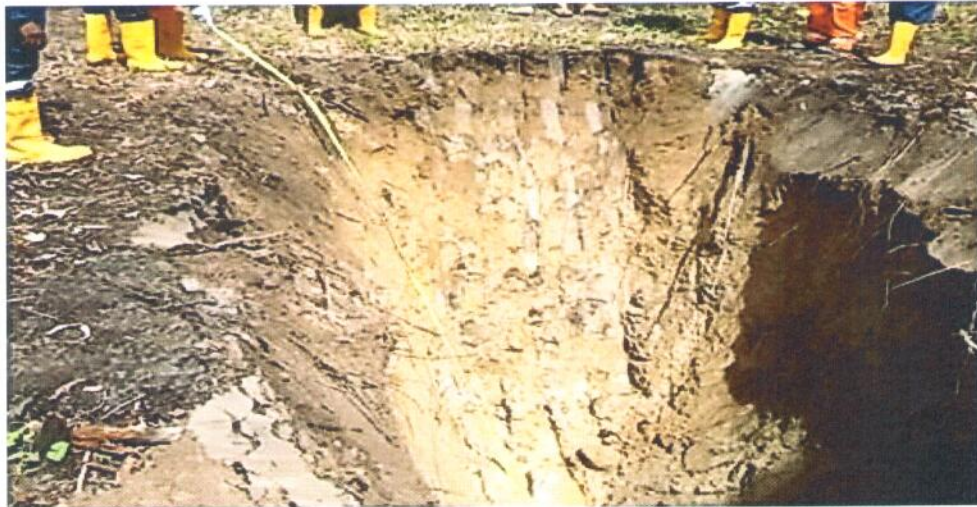
Plate 2a: View if trial pits during site delineation

The method employed in the delineation was digging of trial pits which helped to reveal the vertical profile of the soil and other relevant site contamination information.

- Visual levels of vertical contamination at each point or area
- Presence of Hydrocarbon odour
- Soil profile
- Depth of observable contamination

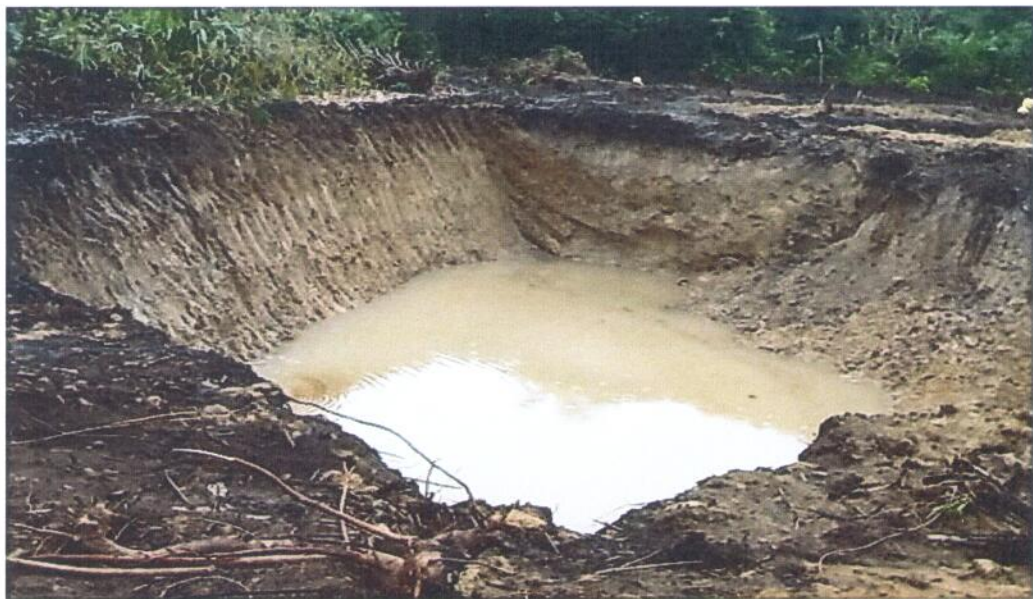
Plate 3a: Excavation process in Hot spot areas

The hot spots were treated using the ex-situ bioremediation technique. The identified spots were dug out to remove all contaminated soil within the spot. The excavated heap was piled on the available areas for treatment. This heap was spread out to a continent level of approximately 0.5 – 0.8 m height. This spreading was to allow for easy nutrient application and subsequent aeration with the heavy equipment.

Approximate Total volume of material = 4,195 m³

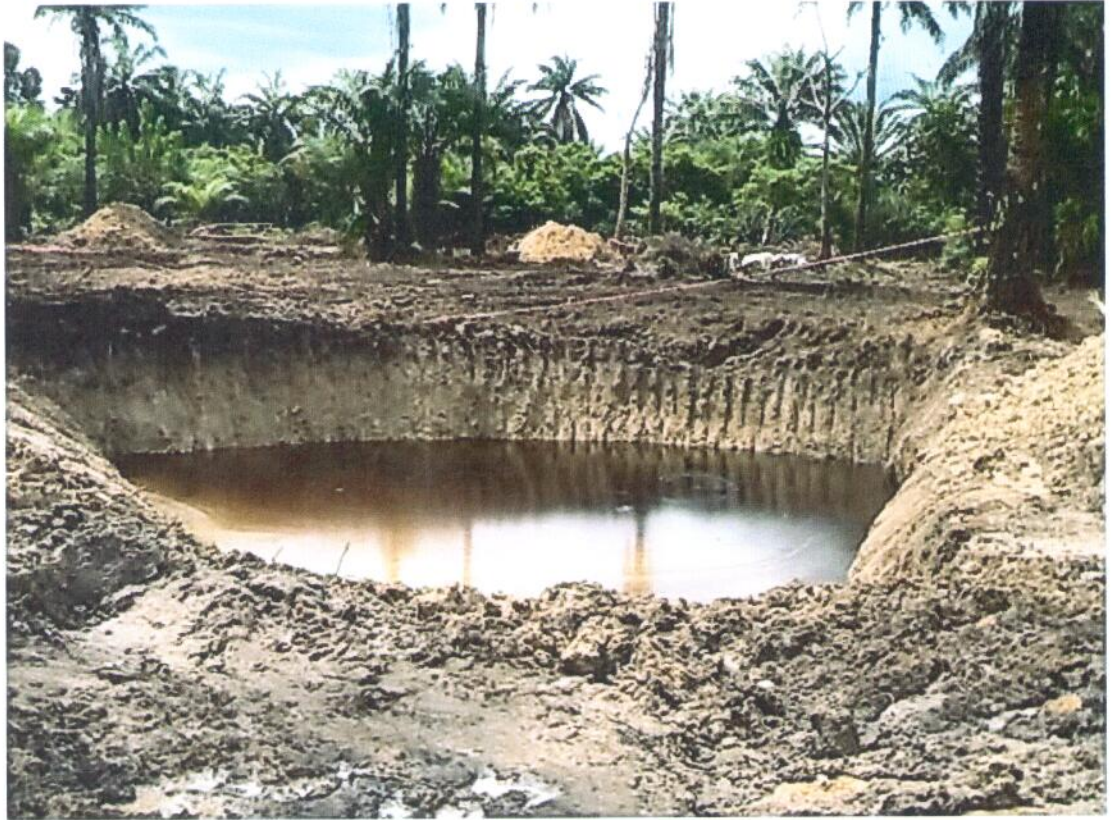
Plate 4: Free phase oil in the excavated pits

During the excavation of the hot spot areas, free phase oil was discovered in the pits due to capillary action.

The alternative means was to resolve to manual recovery by engaging the community labour. Access to the pit was created by the excavator by slopping the pit.

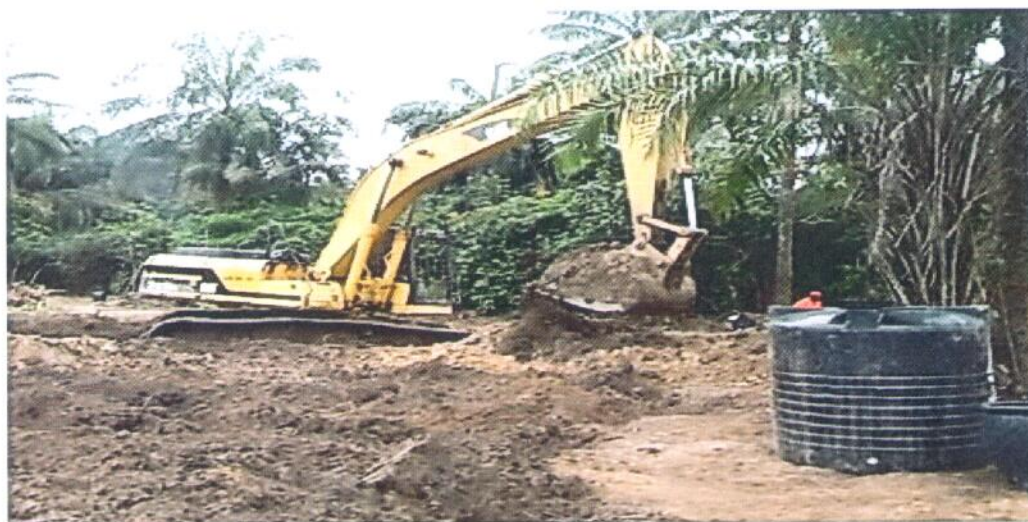
Plate 6: In –situ Homogenization process

Each sub-divided portion was dug up to a depth of about 2 meters that is, the excavator dug up contaminated soil at the same spot vertically, and two buckets down to remove contaminated soil. The removed soil was placed on untilled areas, homogenised and treated with MPCD amendment and the dug up pit was backfilled with treated materials. The process was repeated for all the areas under treatment until the site was uniformly tilled and treated.

Owing to the loose nature of the soil and the process of homogenization, the mix when applied was able to gain a high percentage of penetration into the soil.

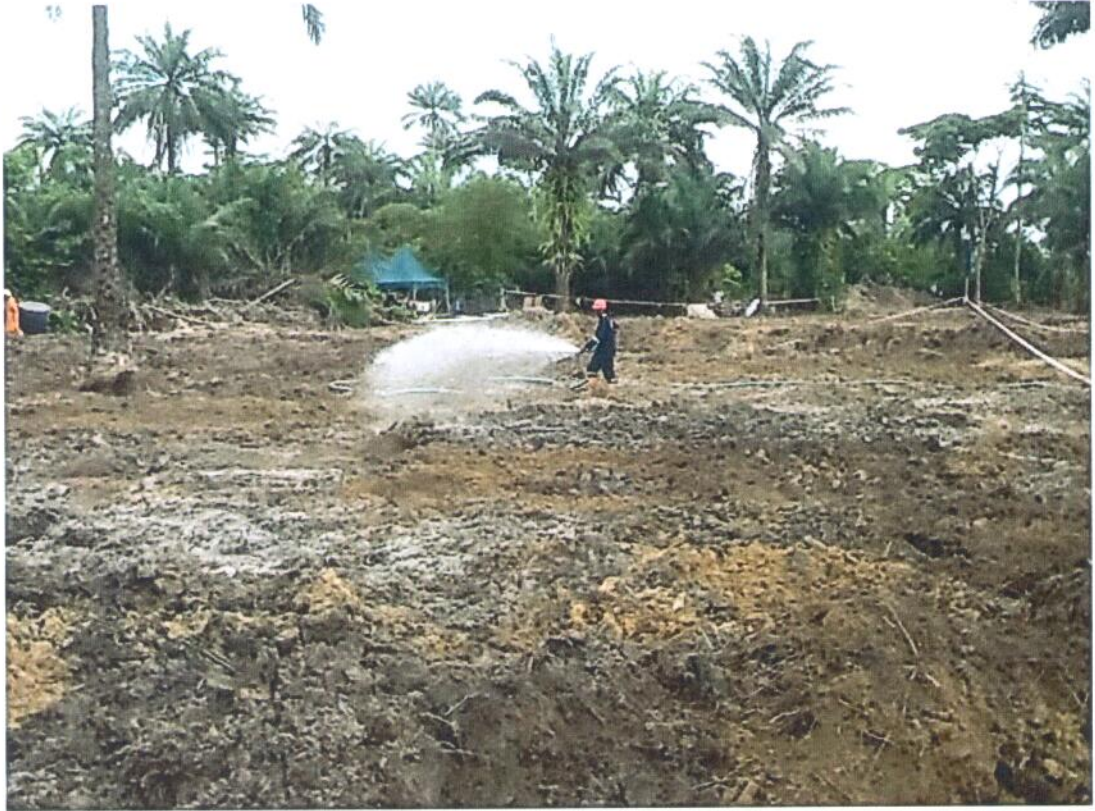
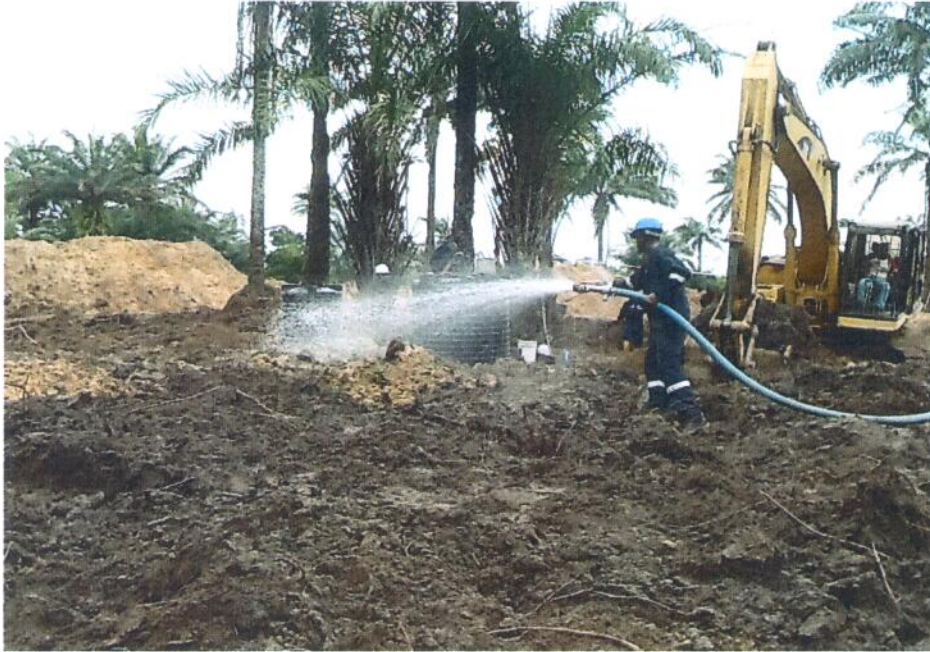
Plate 7: Product application process

The pressure washer was used for the application of MPCD on the treatment areas. The Pressure washer sprays the product "like rain" allowing the Product to soak in completely to the soil. The nozzle of the pressure washer was aimed at sufficient distance away from the soil to prevent erosion of the soil.

1. Diesel powered pressure washer rated at 2500 psi with a flow rate of 15-20 lt/min.
2. Water storage facility to allow mixing of product/water.
3. 2" water pumps with hoses.

Product may be supplied as super concentrate or pre-mix ratio. If product is supplied as super concentrate, then the product should be pre mixed with water to produce 1% MPCD solution

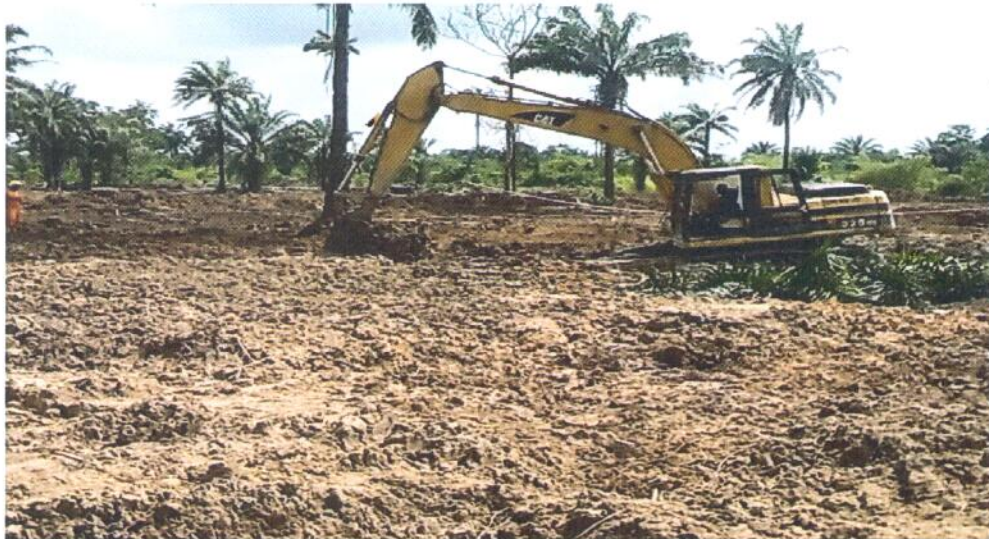
Plate 8: Soil tilling process

The soil under reclamation was land farmed successively with heavy equipment after each round of MPCD application to allow for proper aeration and hence, biodegradation process.

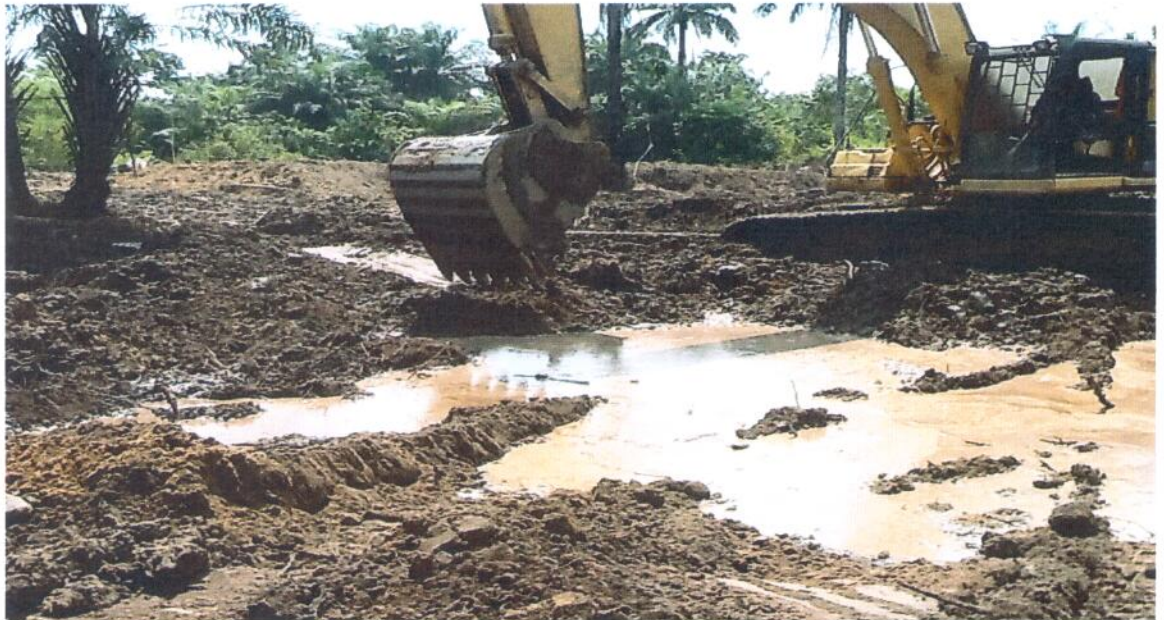
Plate 9: Excavator Backfilling pits after recovery of free oil.

The backfilling of ecavated pits was undertaken after the recovery of the free phase oil and treatment of the excavated soil. The contaminated soil removed from the pits were spread and treated with MPCD product and the treated soil was used in the backfilling of the pits.

After the backfilling of the pits, the pit areas were again landfarmed and MPCD re-applied on the areas.

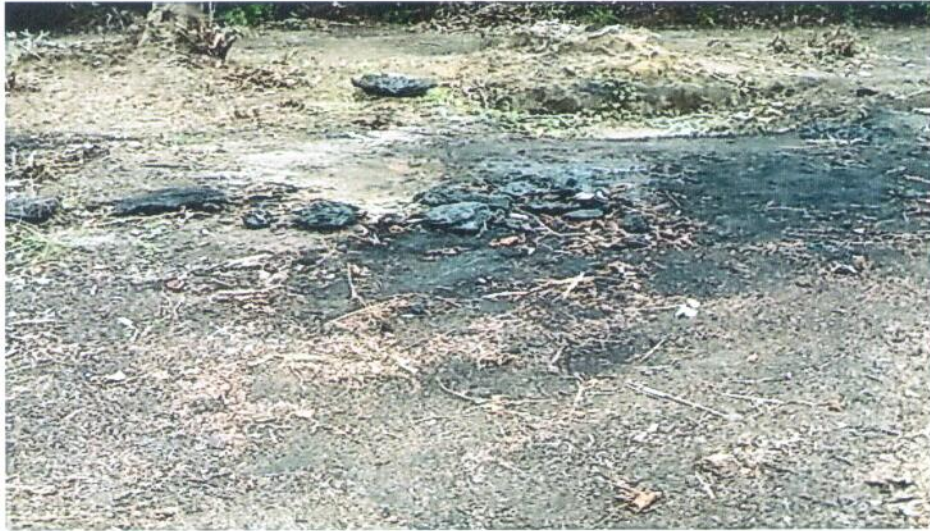
Plate11: View of Carbonised materials at the site before start of remediation

This waste stream was found on site mostly at areas that were used as cooking pits by the illegal refineries. It was a caked material of soil mixed with crude oil and partially burnt. This type of material was broken to smaller aggregates and bulked, homogenised with soil and treated with the product.
